M300 RTK Known Issue List

Released date	2022.05.11
Aircraft Firmware:	v04.00.01.11
Remote Controller Firmware:	v04.00.01.10
Pilot App Android	v4.0.1.14
D-RTK 2 Mobile Station for Matrice:	v03.01.00.00 (D-RTK 2 Mobile Station: v03.01.00.00)
Intelligent Battery Station:	v04.00.01.02
Intelligent Flight Battery:	v01.02.05.43
Zenmuse H20 / H20T:	v04.00.00.10

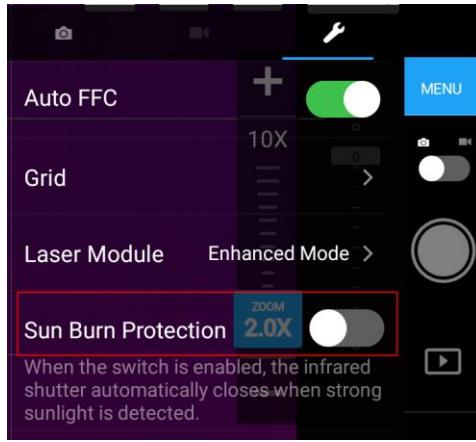
1.	<p>When H2OT is aimed at an object with a high temperature, the Sun Burn Protection function may be triggered, and there will be an option to allow you to disable the protection. However, after you disable it, later the Protection will still be triggered.</p>	<p>Please disable the Sun Burn Protection function in the camera setting page.</p>
