M300 RTK Known Issue List

Released date	2023.03.09
Aircraft Firmware:	v06.01.01.00
Remote Controller Firmware:	v06.01.01.00
Pilot App Android	V6.1.2.3
D-RTK 2 Mobile Station for Matrice:	v03.01.00.00 (D-RTK 2 Mobile Station: v03.01.00.00)
Intelligent Battery Station:	v04.00.01.03
Intelligent Flight Battery:	v01.02.05.44
Zenmuse H20 / H20T:	v04.01.03.00

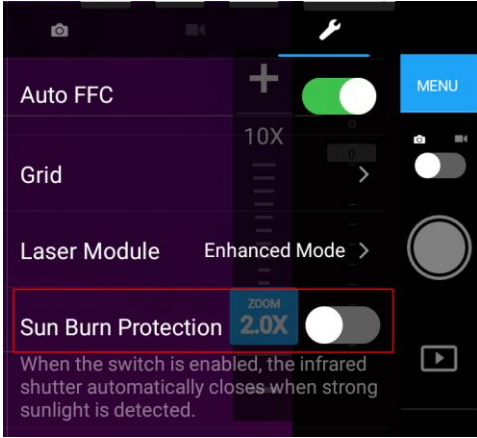
<p>1.</p>	<p>When H20T is aimed at an object with a high temperature, the Sun Burn Protection function may be triggered, and there will be an option to allow you to disable the protection. However, after you disable it, later the Protection will still be triggered.</p>	<p>Please disable the Sun Burn Protection function in the camera setting page.</p>
